# Holden wins 2007 TPM<sup>3</sup> Aussie Cup

## Block Busters are ‘Ready to Go’

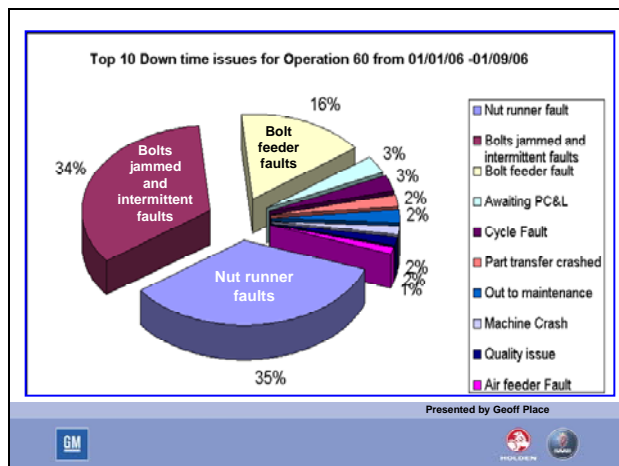
The team gathered data relating to issues on the line and the frequency with which they occurred. Most of the trouble seemed to emanate from one station, Station 8.

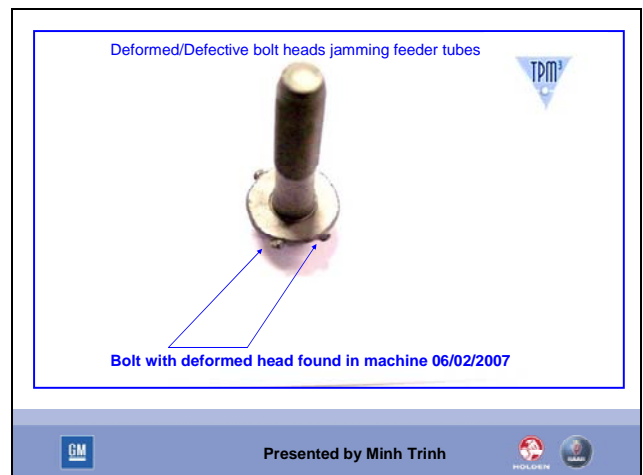
Whilst compiling the data the team also noted that there were numerous problems with parts. Some of the deformed and defective bolts were blocking the feeder tubes and others were rotating completely on presentation at the chuck head. This led to downtime as the nut runners that automatically drive home the bolts couldn’t complete their function.
